Nine 18th-century Milestones on the ‘Old Galway Road’ from Gort to Galway.

Conservation Report

Gerry McManus, conservation architect

Ardrahan Heritage Group.

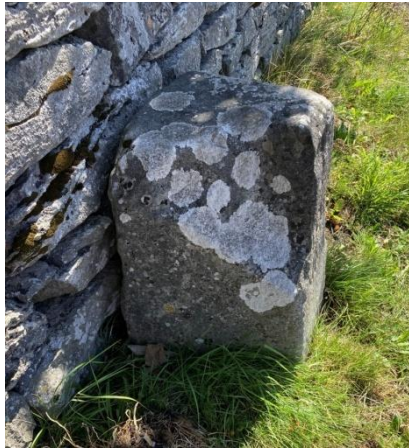
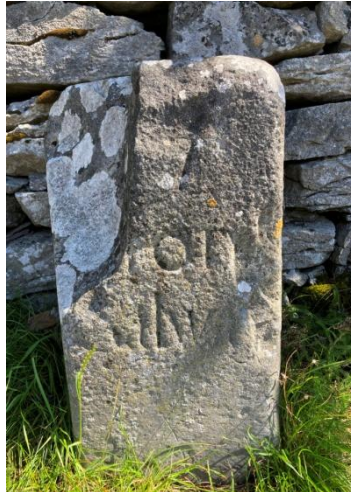
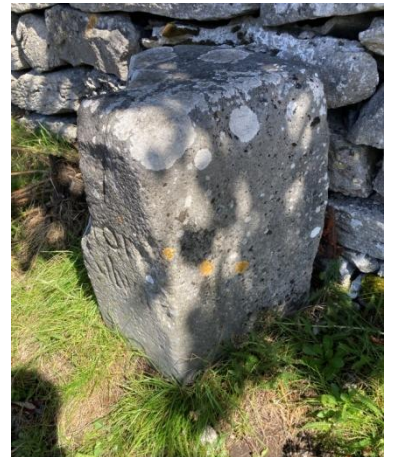
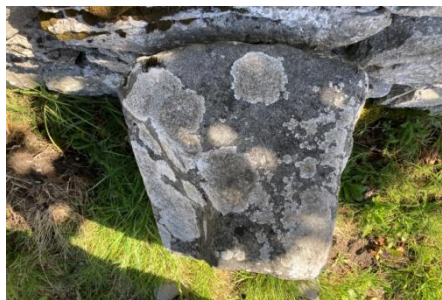
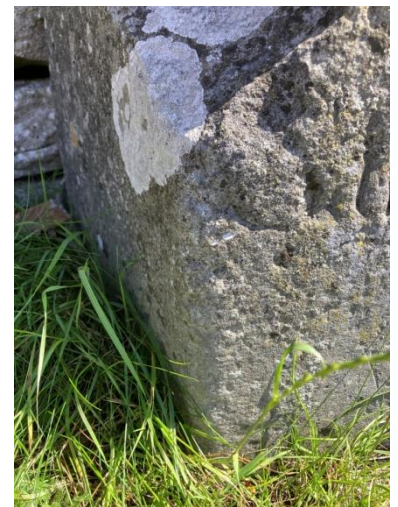
Milestone No. 1

Close up views of stones

Tooled chamfer on front edge

Limestone pillar with flat top and trapezoidal cross-section. Wider at the rear and tapering to the front. Generally well-dressed stone with a narrow chamfer to the front angles. Severe spalling to face and angle on upper left side; lesser spalling to top and right angle. Lichens. Inscription badly damaged by spalling but would probably have read '17 From Galway'.

Damage appears to be historic as spalled edges and damaged faces are weathered and not sharp, and lichens have already colonised the broken areas.

A mortar repair should be undertaken on the face and angle on the upper left side, and possibly in the area on the right side of the face approximately half way down. This would allow the missing text to be re-carved on the stone. It would involve a small amount of redressing of the edges of the damaged parts to allow insertion of the repair. A more conservative option might be to omit the mortar repair on the right, where damage is less severe and simply paint in the text on this side.

At minimum the stone should then be protected against future damage. Its urban site means it is unlikely to be susceptible to mechanical damage due to verge cutting with large machinery but there is still some risk of damage from grass mowing if the area around it is left as grass. Other surface treatments may be preferred as discussed above.

However, perhaps moving this stone should be considered. Evidence suggests it has already been moved. Where it is situated at present it is lost among other miscellaneous street furniture. If it were moved to between the nearby two entrances as indicated in the photograph below it would enjoy greater prominence and a visually calmer setting. It would also be closer to its original position.

Painting the milestone should be considered. A low-key approach might find only the lettering picked out with paint (white? black?), but it may be desirable to paint the entire stone white and pick out the text in black. This approach would cover any variations in colour between the stone and the repair mortar, thus aiding the appreciation of the object as a whole.

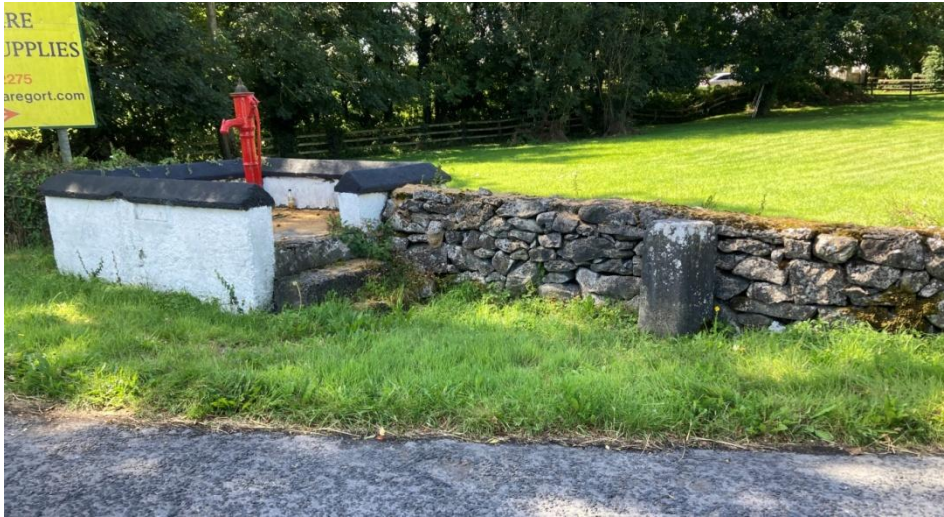
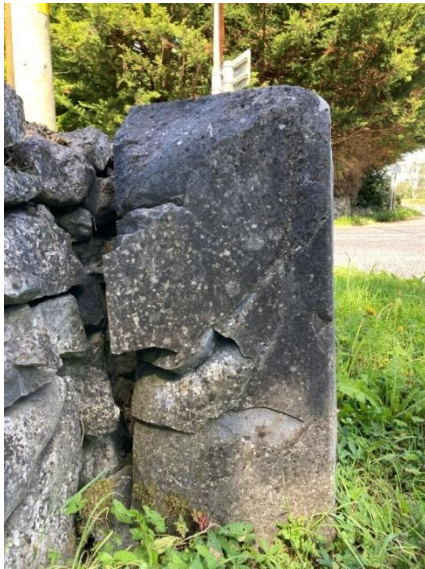
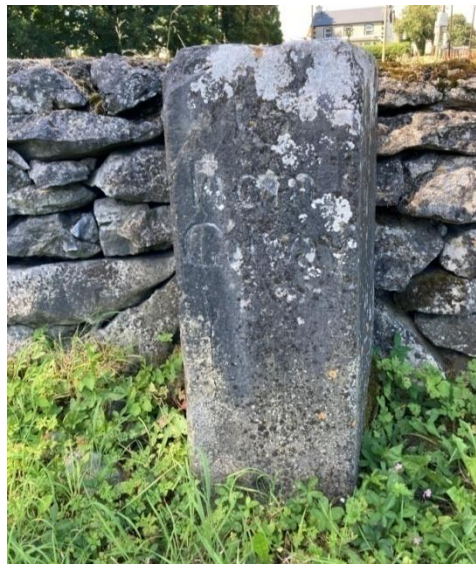
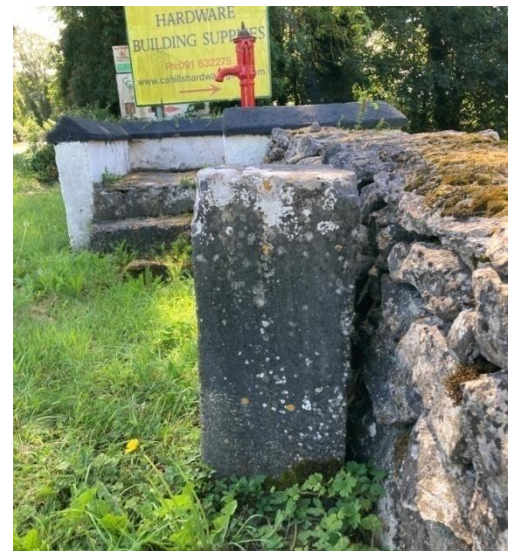
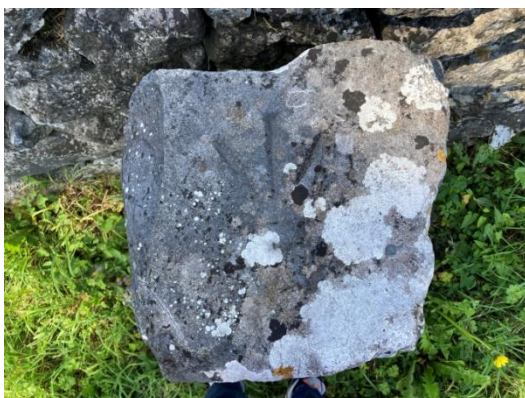
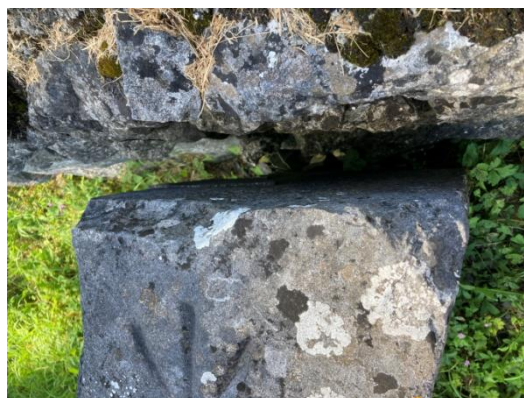
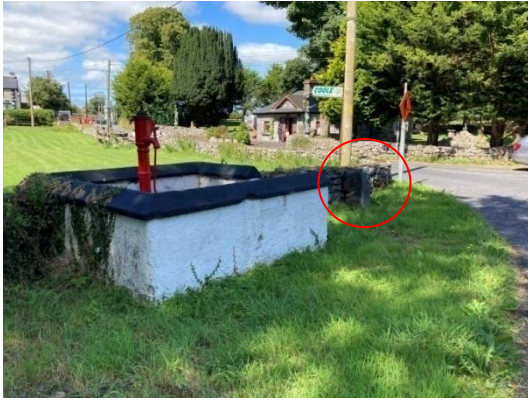
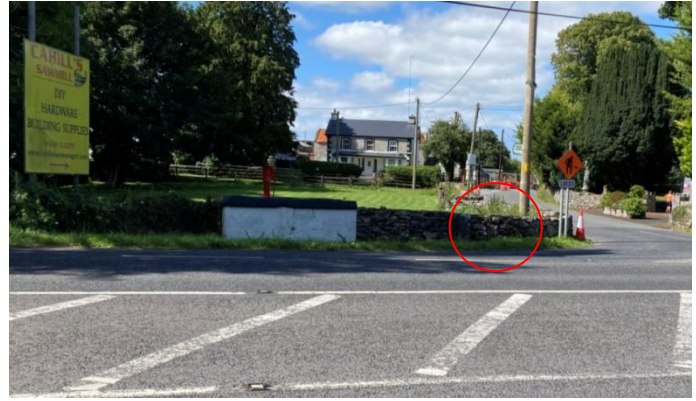
Milestone No. 2

Limestone pillar with flat top and trapezoidal section, Wider at back and tapering to front. Dressed stone with even surfaces and narrow chamfer to front angles. Inscription '16 From Galway' on front is well preserved. Ordnance Survey bird's foot benchmark deeply inscribed on top with square recess and central bore (for a surveying instrument?). Traces of white paint remain where in recent years the inscription was picked out in paint. Slight spalling to upper right and left angles. Very heavy recent spalling to the rear. Cracks running top-to-bottom on front and left sides of the stone indicate a heavy impact, possible a vehicle collision. Lichens.

There is severe damage to this stone. Cracks and spalling need to be repaired to avoid possible future disintegration of the damaged parts of the stone. Prior to mortar repair it will be necessary to inject the cracks with a 2 part stone glue (by 'Sika' or other agreed, to spec.). This will mean the careful drilling of holes along the cracks to facilitate the injection. It may also be necessary to use stainless steel pin(s) to reinforce the repair – to be agreed following further examination. Finishing with a mortar repair on the rear left side would then ensure that water does not lodge in the damaged areas. As mortar repair involves a small amount of redressing of stone, it is preferable to confine it to areas where it is necessary. Mortar repair simply to regularise the profile of the stone is not essential.

Painting the milestone should be considered. A low-key approach might find only the lettering picked out with paint (white? black?), but it may be desirable to paint the entire stone white and pick out the text in black. This approach would cover any variations in colour between the stone and the repair mortar, thus aiding the appreciation of the object as a whole.

At minimum the stone should then be protected against future damage. Its particular site adjacent to the water pump enclosure means it is unlikely to be susceptible to mechanical damage due to verge cutting with large machinery but there is still some risk of damage from grass mowing if the area around it is left as grass. Other surface treatments may be preferred as discussed on page 6.

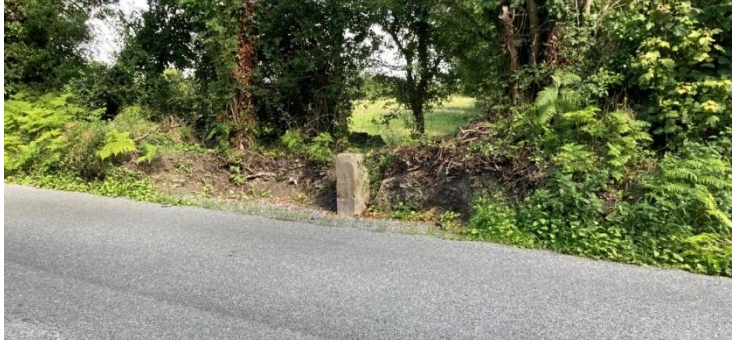
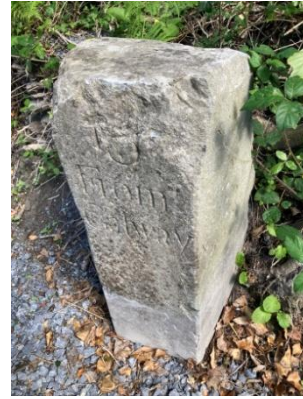
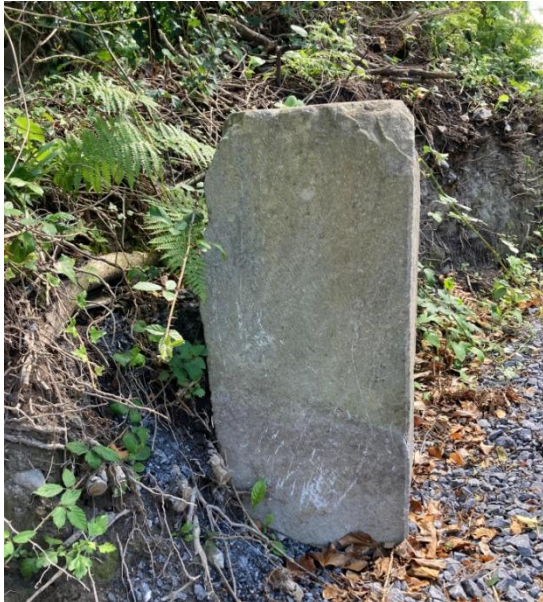
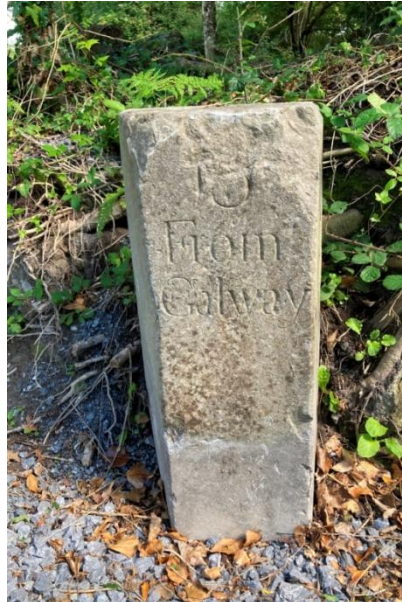
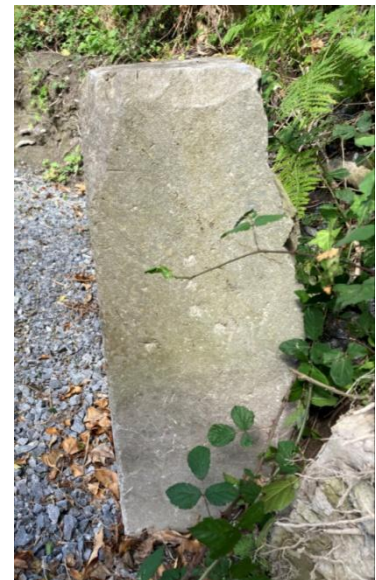
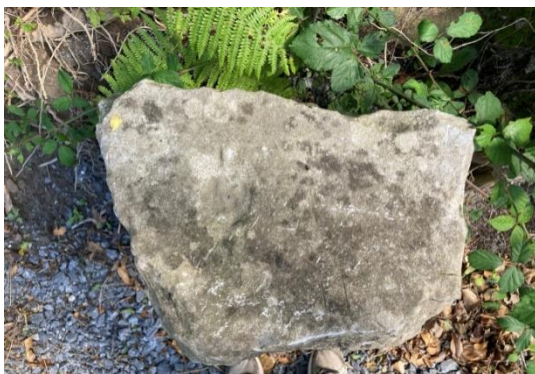
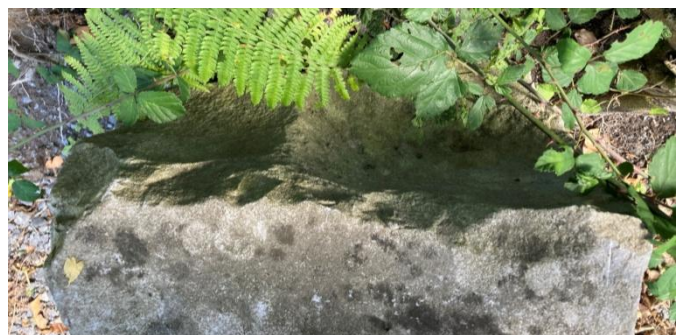
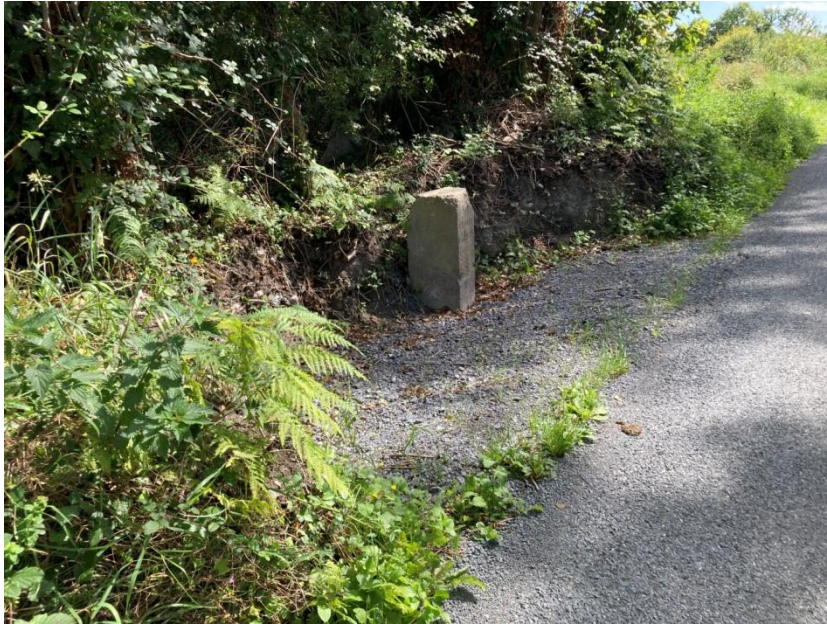
Plan view of top

View looking down at back of stone

Limestone pillar with flat top and trapezoidal section. Wider at back and tapering towards the front. Well dressed with flat faces and narrow chamfer to outer angles. Inscription on front face: 15 From Galway. Upper part of numerals damaged by heavy spalling to upper margin and angles. Very heavy spalling to rear. Lichens.

A mortar repair should be undertaken on the face and upper margins on front angles. Repair at the back of stone is not essential. This minimal repair would allow the missing text to be re-carved on the stone. It would involve a small amount of redressing of the edges of the damaged parts to allow insertion of the repair.

At minimum the stone should then be protected against future damage. Some planned rearrangement of the setting of this milestone has already been undertaken which has gone much of the way to affording it protection. The earthen bank has been cut back to form a recess with the stone sitting centrally, and the area has been floored with a rough chip. As referred to in the discussion on page 6, this finish is not particularly sympathetic and an alternative finish should be considered. However the stone stands out in its setting and the gap in vegetation means that it is clearly visible and can be avoided by verge cutters. Maintenance using hand held tools would be required.

Painting the milestone should be considered. A low-key approach might find only the lettering picked out with paint (white? black?), but it may be desirable to paint the entire stone white and pick out the text in black. This approach would cover any variations in colour between the stone and the repair mortar, thus aiding the appreciation of the object as a whole.

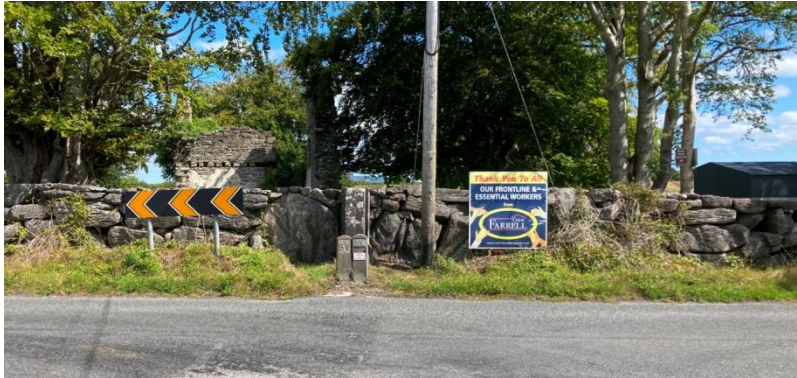
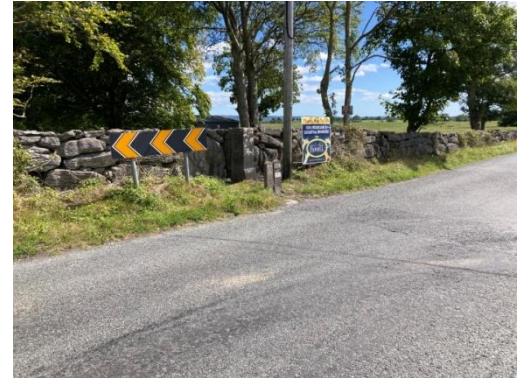
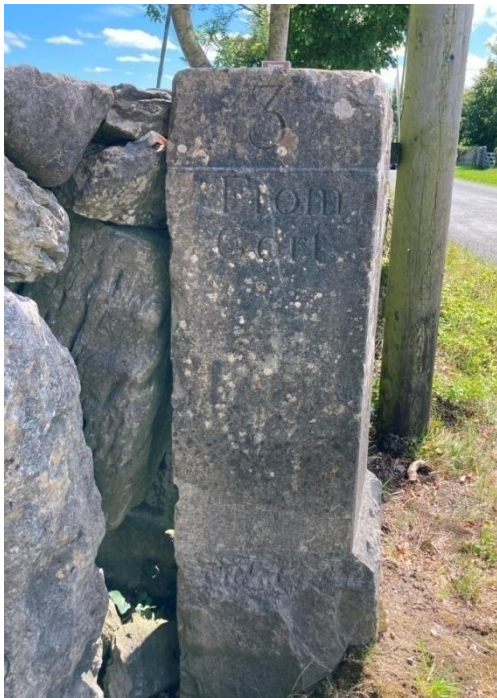
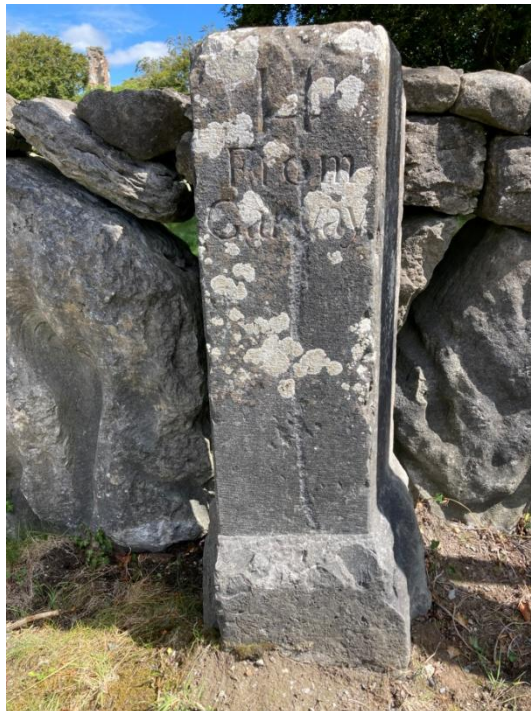
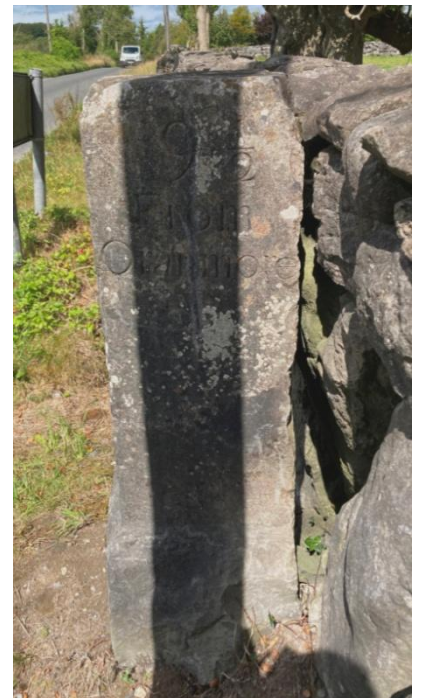
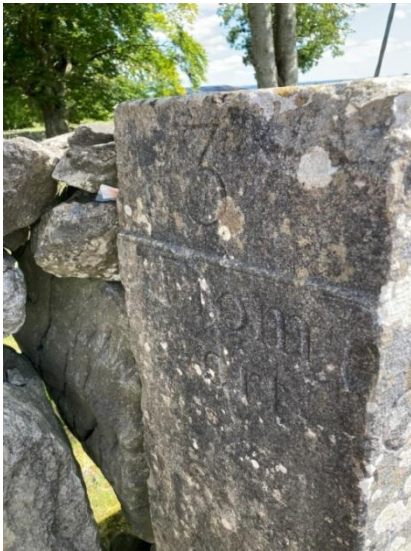
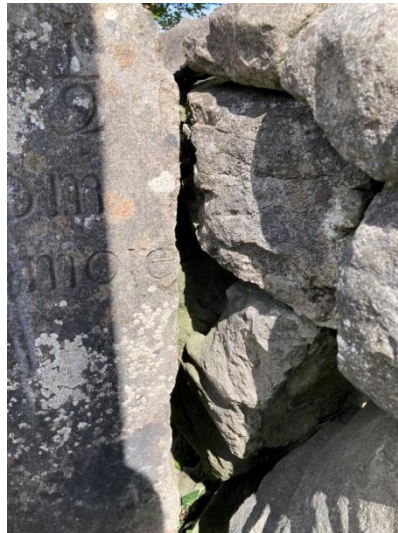
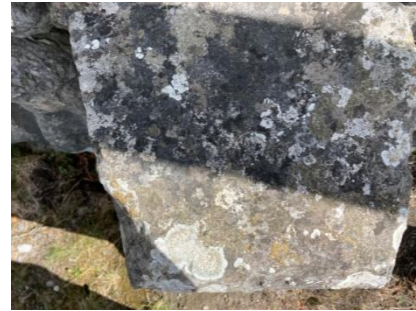
Limestone pillar, trapezoidal in section, wide at rear and narrowing to the front. The upper part is well dressed with flat faces and thin chamfers to the front margins. There are some fine tooling marks (ribbing) on the north face. Spalling to the top and upper margins; not severe. Inscribed on three faces: (north) '3 From Gort'; (front or west) '14 from Galway'; and (south) '9½ From Oranmore'. On the north face a thin light fillet or moulding separates the numeral 3 (above) from the text (below); the face of the stone above the fillet is cut back by < 1 cm. Was there a flaw in the stone? An error by the sculptor? We can only speculate. Towards the base, the roughly hewn lower part of the stone (0–46 cm) is exposed and was clearly intended to be the buried or below-ground part of the stone originally.

As the spalling on this stone is not severe and the inscription is clearly legible, no mortar repair is proposed.

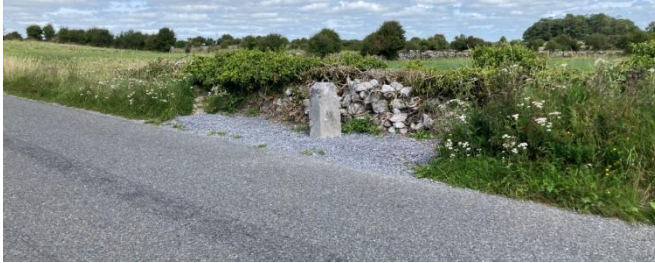
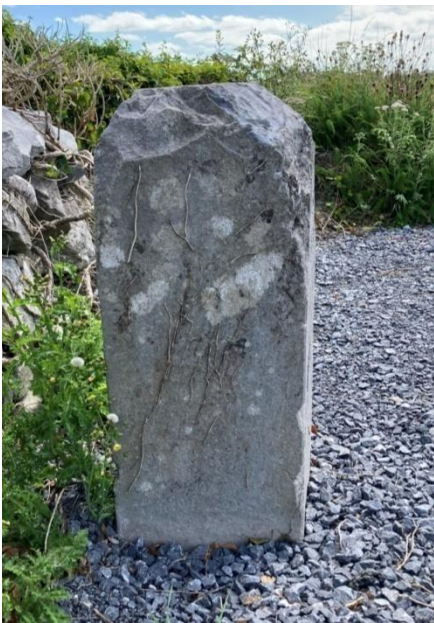
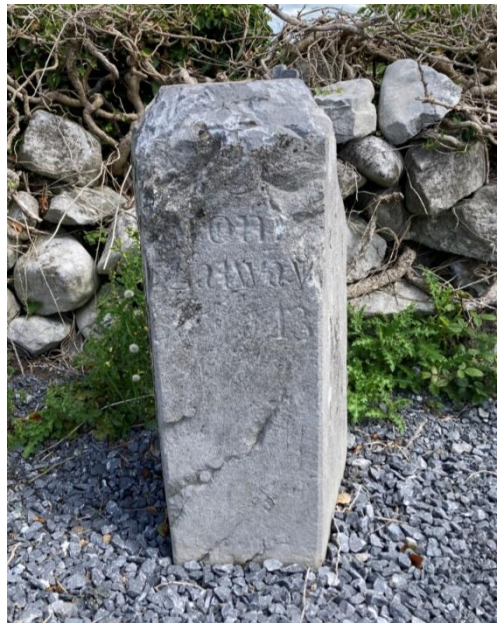
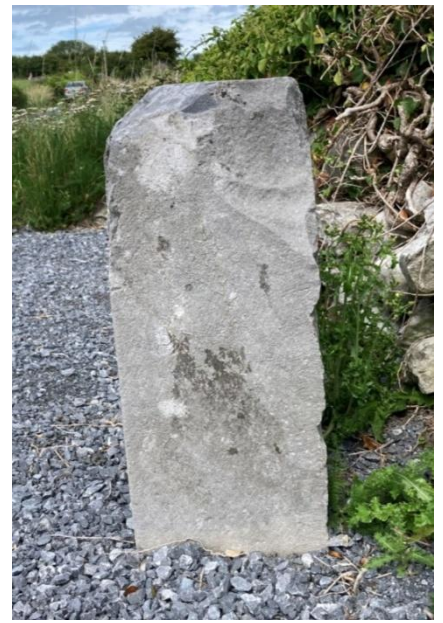
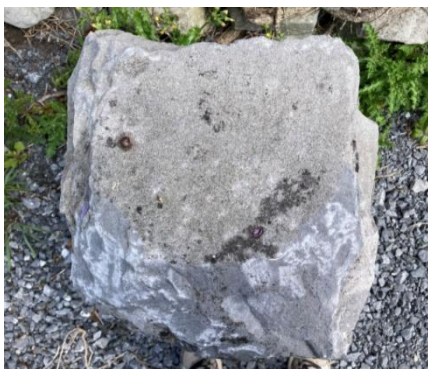
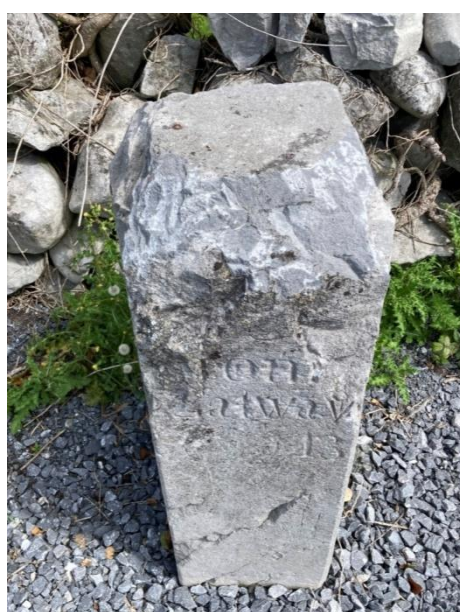
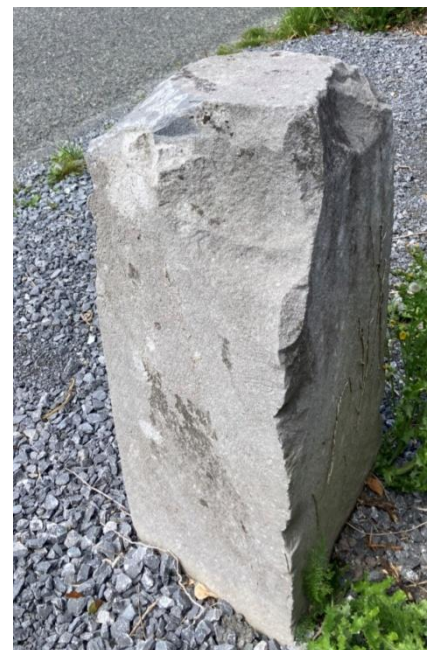
Limestone pillar. Trapezoidal on plan. Wider at back and tapering to front. Well dressed even faces with slight chamfer (1 cm) to front angles. The upper part of the stone, all around the top and at the front margins, is very badly spalled. The inscription is weathered and partly obliterated by spalling but would have read: '13 From Galway'.

A mortar repair should be undertaken on the face and upper margins on front angles. Repair at the back of stone is not essential. This minimal repair would allow the missing text to be re-carved on the stone. It would involve a small amount of redressing of the edges of the damaged parts to allow insertion of the repair.

Removal of algae and lichens from the areas to be repaired would be required. This should be done using water and a stiff bristle brush initially, followed by surface preparation in line with mortar manufacturer's specifications. Redressing of original stone should be kept to an absolute minimum. Skilled tradespeople should be used to undertake the work.

At minimum the stone should then be protected against future damage. Some planned rearrangement of the setting of this milestone has already been undertaken which has gone much of the way to affording it protection. The earthen bank has been cut back to form a recess with the stone sitting centrally, and the area has been floored with a rough chip. As referred to in the discussion on page 6, this finish is not particularly sympathetic and an alternative finish should be considered. However the stone stands out in its setting and the gap in vegetation means that it is clearly visible and can be avoided by verge cutters. Maintenance using hand held tools would be required.

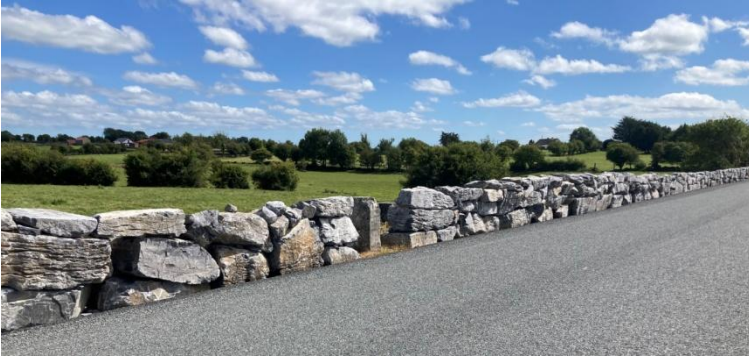
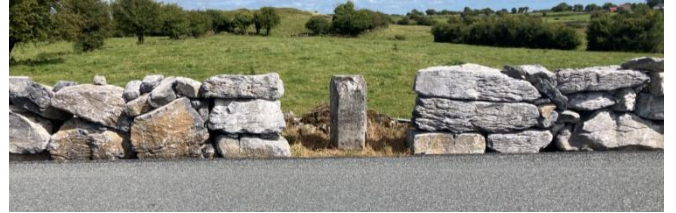
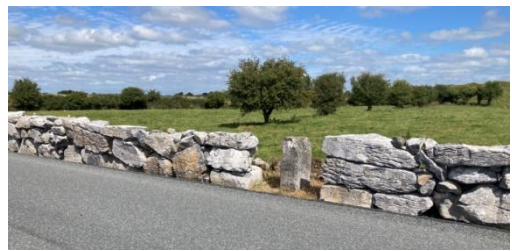
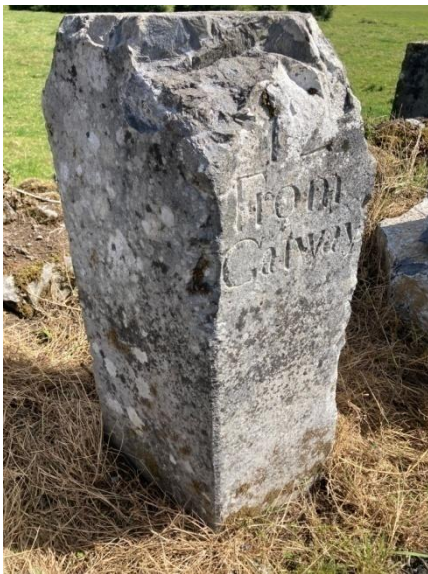
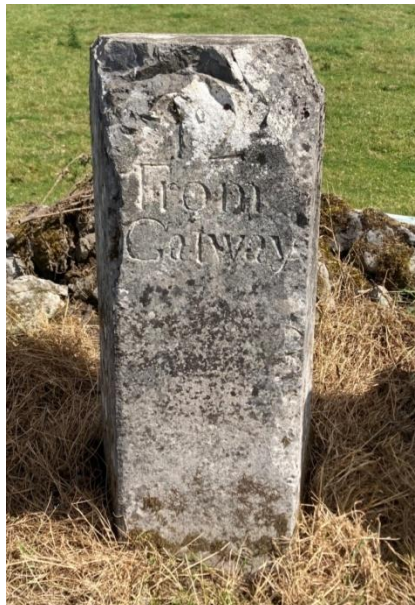
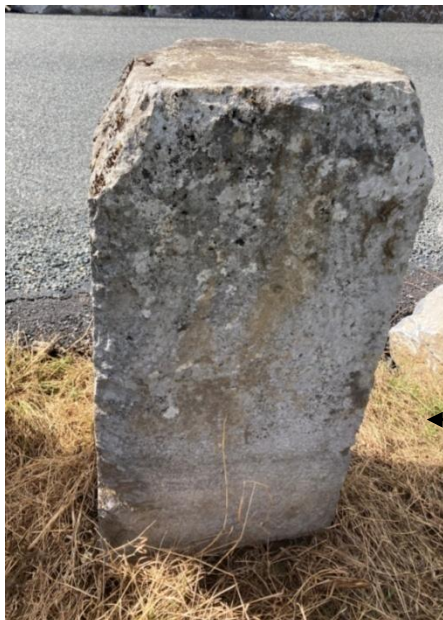
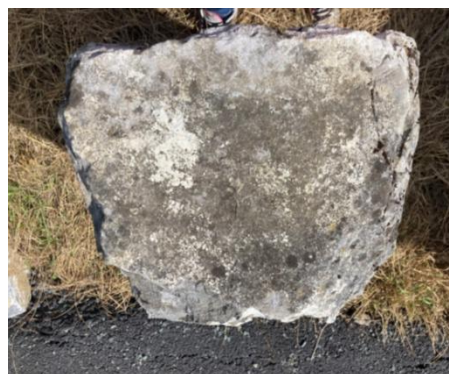
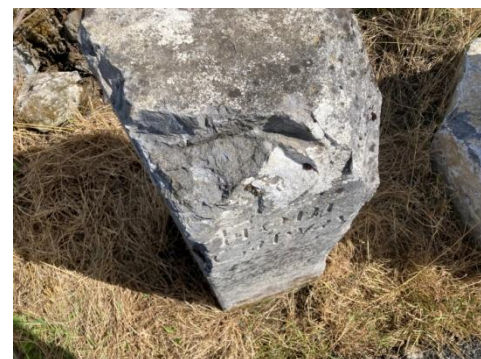
View of top of stone
Rear of stone

Limestone pillar. Trapezoidal section. Wider at rear and tapering to front. Well-dressed upper part with narrow chamfer (< 1 cm) to front margins. Lower part more massive, roughly hewn base, clearly intended to be buried. Heavy spalling to the crown, some evidently recent; also lighter spalling to the front margins. Inscription '12 From Galway' but numerals partly obliterated by spalling. Faint traces of white paint (modern) where inscription picked out. Lichens, mosses.

A mortar repair should be undertaken on the face and left hand and central upper margins on the front of the stone. Repair at the back and on the right of the stone is not essential. This minimal repair would allow the missing text to be re-carved on the stone. It would involve a small amount of redressing of the edges of the damaged parts to allow insertion of the repair.

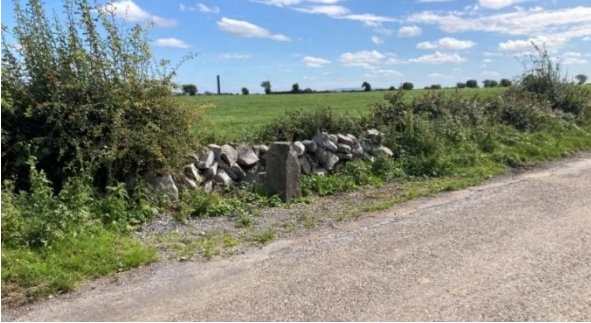
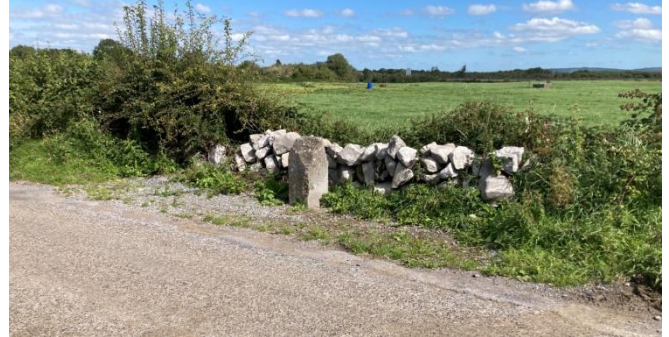
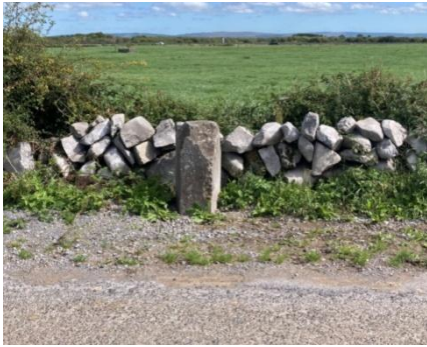
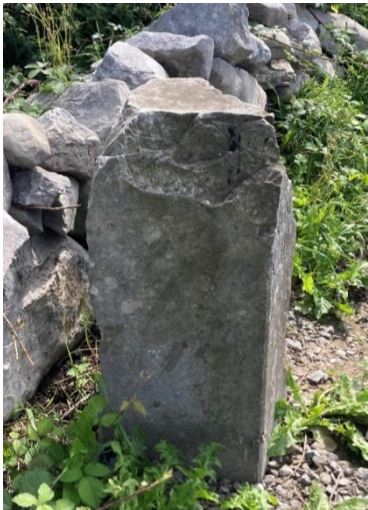
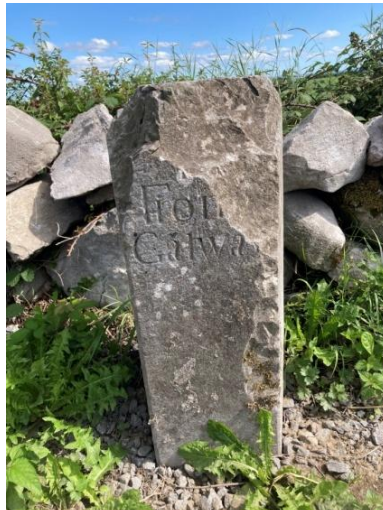
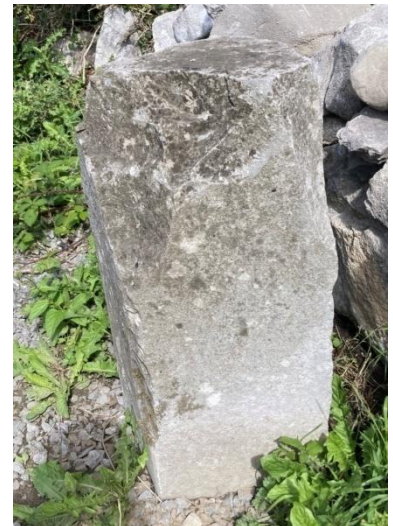
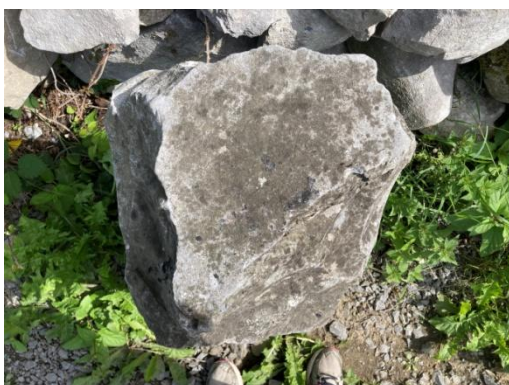
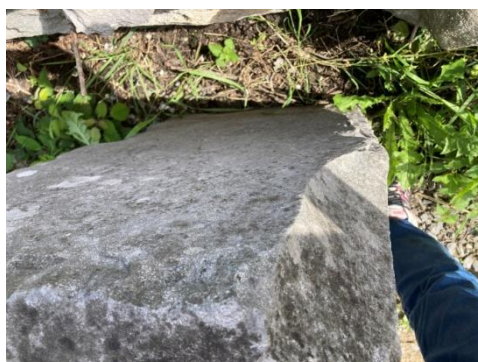
Limestone pillar. Trapezoidal section. Wider at rear and tapering to front. Well dressed stone with flat, even faces and narrow chamfer (< 1 cm) to front margins. Very heavy spalling to the crown and upper front margins and part of the upper front face. Inscription weathered and partly obliterated. Probably: '11 From Galway'. Lichens.

A mortar repair should be undertaken on the face and upper margins on front angles. Repair at the back of the stone is not essential. This minimal repair would allow the missing text to be re-carved on the stone. It would involve a small amount of redressing of the edges of the damaged parts to allow insertion of the repair.

At minimum the stone should then be protected against future damage. Some planned rearrangement of the setting of this milestone has already been undertaken which has gone much of the way to affording it protection. The earthen bank has been cut back to form a recess with the stone sitting centrally, and the area has been floored with a rough chip. As referred to in the discussion on page 6, this finish is not particularly sympathetic and an alternative finish should be considered. However the stone stands out in its setting and the gap in vegetation means that it is clearly visible and can be avoided by verge cutters. Maintenance using hand held tools would be required.

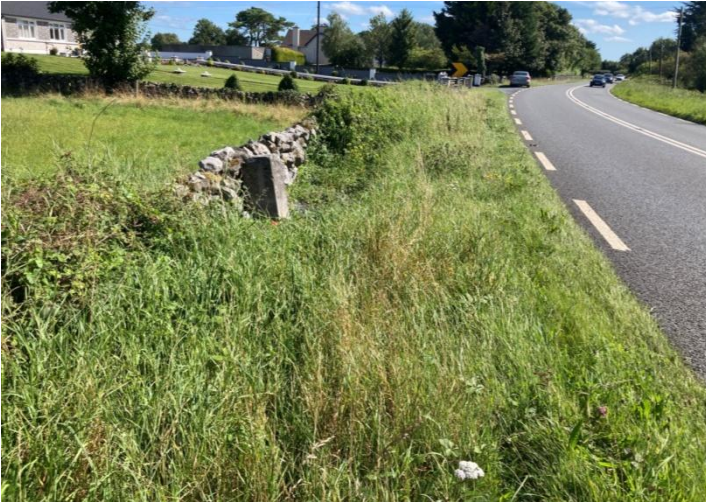
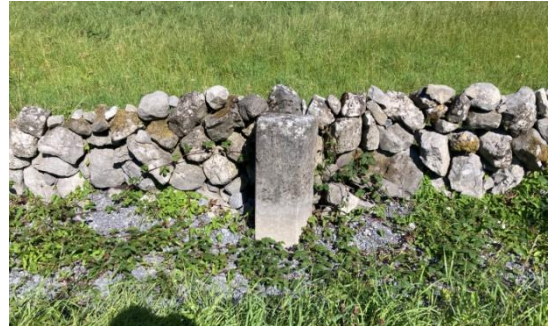
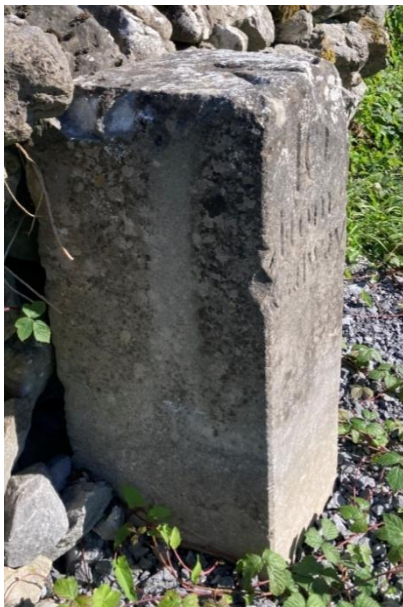
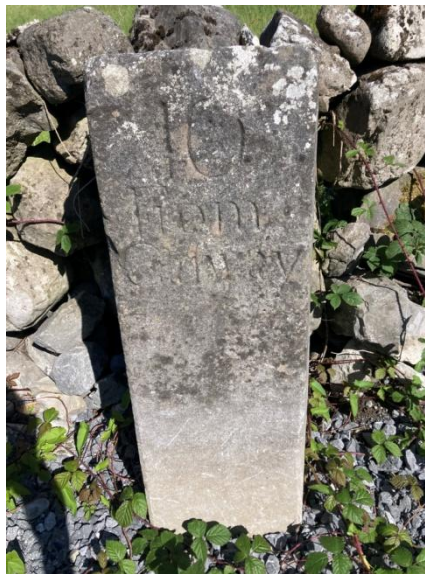
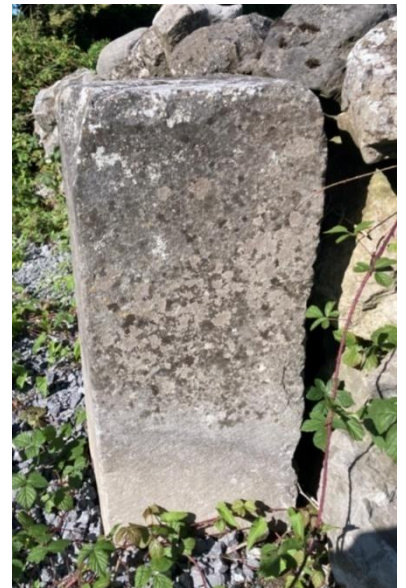
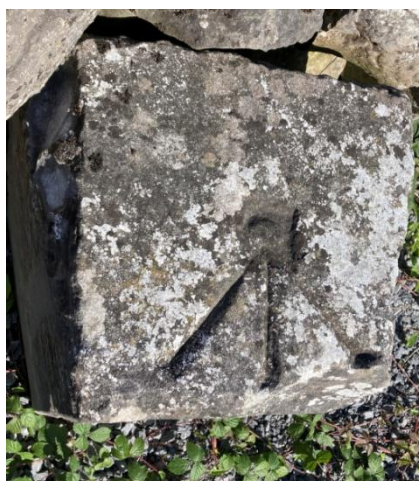
Limestone pillar. Trapezoidal in section. Wider at rear and tapering to front. Well dressed stone with even faces. Very slight chamfer to front margins (< 0.5 cm). One major spall to top right of front face. Lichens. Inscription on front '10 From Galway' but numeral 0 partly removed by spall. Ordnance Survey bird's foot benchmark to top with three deeply engraved lines radiating from a shallow square recess.

The position of this milestone is very low compared to the level of the road which has obviously been raised considerably over time. In conservation terms, as it includes a benchmark, it would generally be considered undesirable to move it. However, as it stands, it is vulnerable to damage from verge cutting, and it enjoys minimal visibility from the road. For these reasons it may be justifiable to move it but the alteration should be properly recorded.

A mortar repair should be undertaken on the face and upper margins on front angles. Repair at the back of the stone is not essential. This minimal repair would allow the missing text to be re-carved on the stone. It would involve a small amount of redressing of the edges of the damaged parts to allow insertion of the repair.

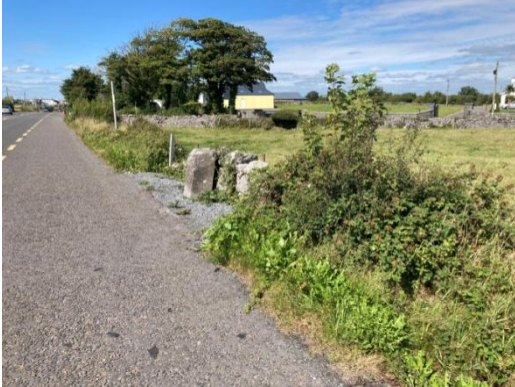
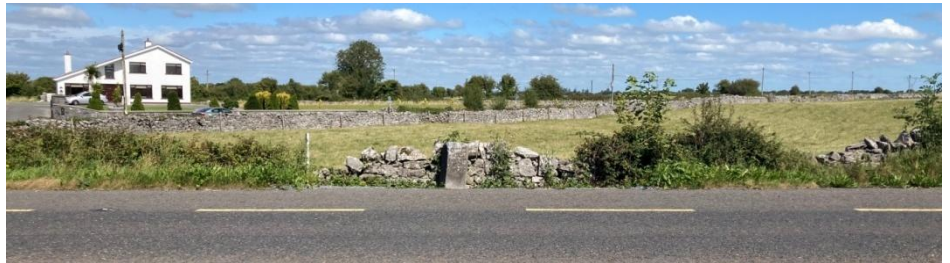
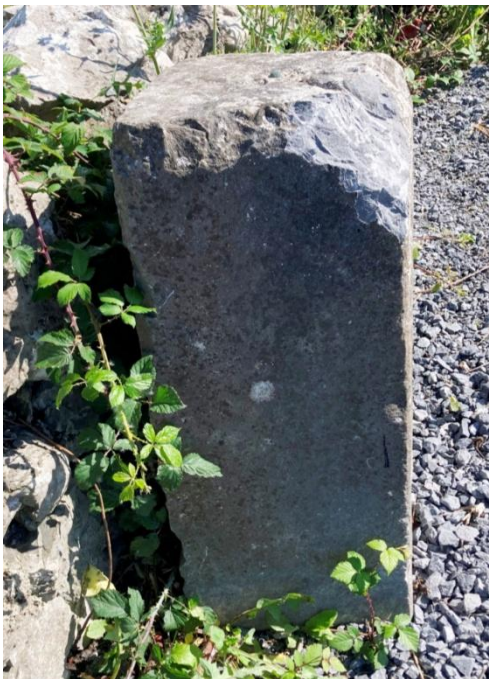
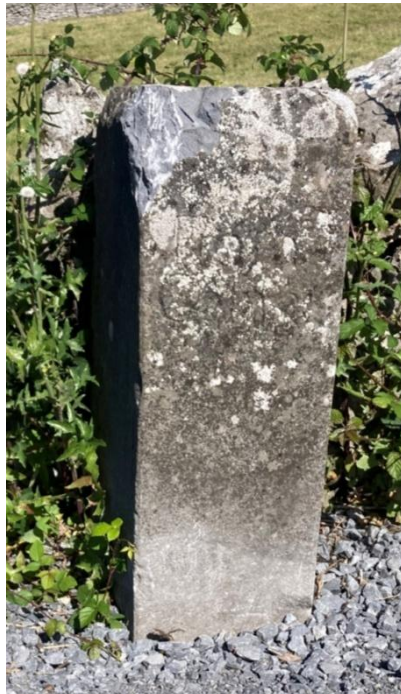
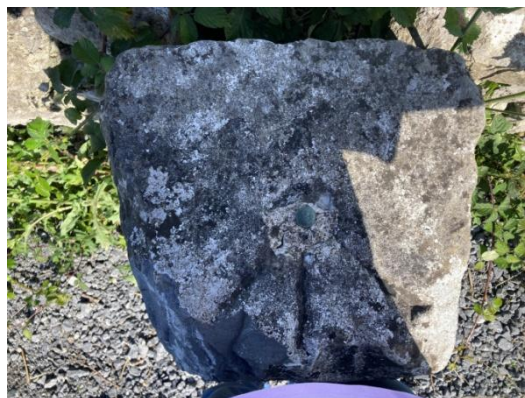
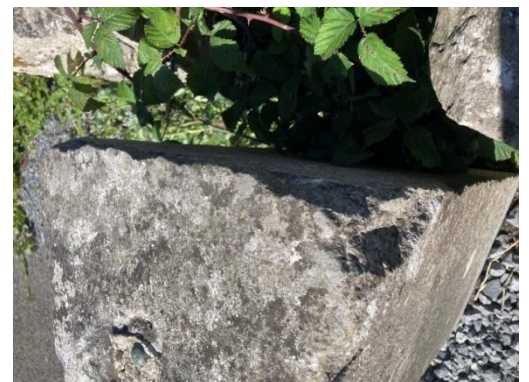
Limestone pillar. Trapezoidal in section. Wider at rear and tapered to front. Well dressed even faces with slight chamfer to front margins (< 1 cm). Inscription to front '9 From Galway'. Ordnance Survey bird's foot benchmark on top: here deep lines radiating from circular recess with round bronze boss still in situ in circular recess. Moderate spalling to mid right margin and around crown at front and right. Severe spalling at top left. (This is evidently recent.) Lichens.

A mortar repair is not necessary in order to ensure legibility. In this case the inscription is intact. However the recent damage on the top has left some indents which might hold water and a limited mortar repair to ensure effective water run-off may be advisable.

At minimum the stone should then be protected against future damage. Some planned rearrangement of the setting of this milestone has already been undertaken which has gone much of the way to affording it protection. The earthen bank has been cut back to form a recess with the stone sitting centrally, and the area has been floored with a rough chip. As referred to in the discussion on page 6, this finish is not particularly sympathetic and an alternative finish should be considered. However the stone stands out in its setting and the gap in vegetation means that it is clearly visible and can be avoided by verge cutters. Maintenance using hand held tools would be required.
